University of Canterbury

Experimental Study on the Seismic Performance of Low Damage Systems for Non-structural Light Framed Plasterboard Partition Walls

ENEQ690 Master's Thesis

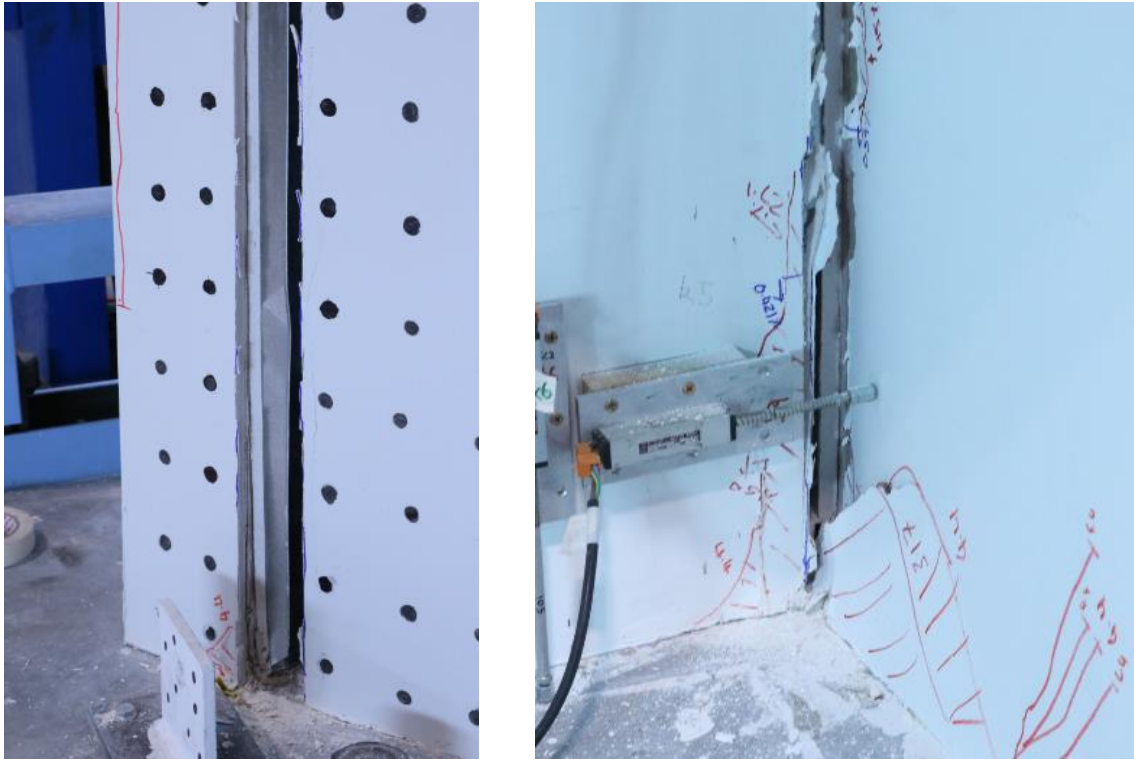
Figure C.22 Specimen B1 – Step 15 – separation of main wall from return wall – location 6 (left) & 11 (right)

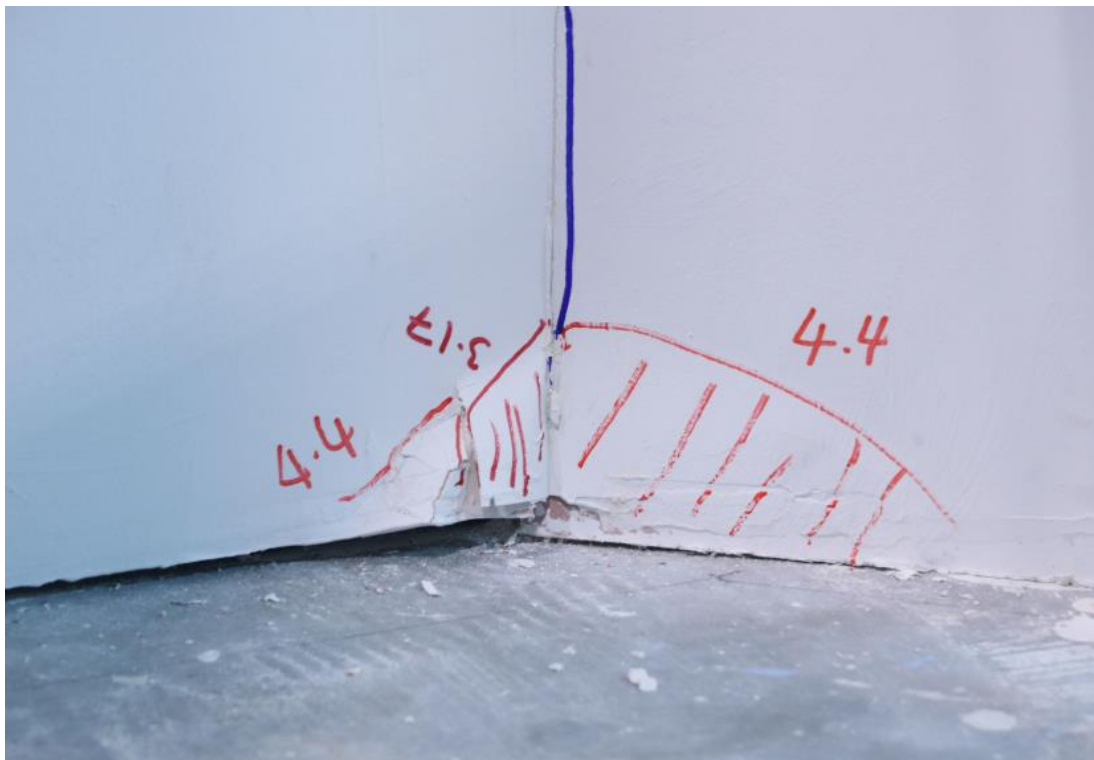
Figure C.23 Specimen B1 – Step 15 –DS2a: Damage to wallboard at Y-junction – location 19

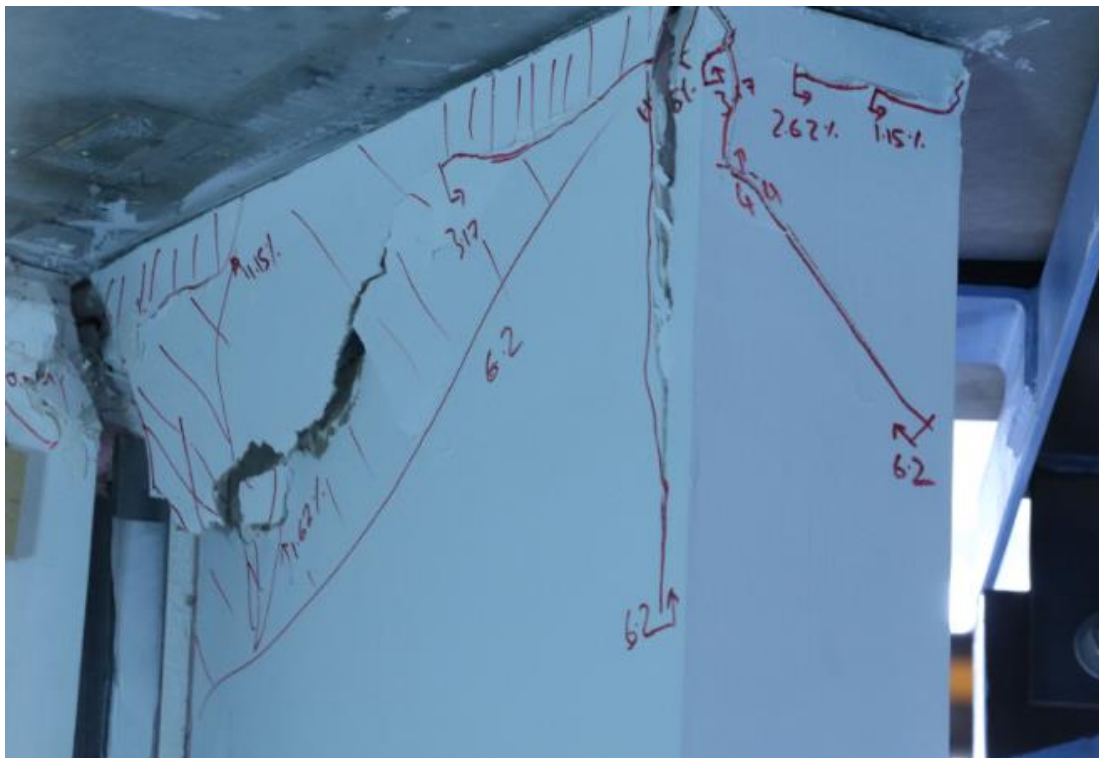
Figure C.25 Specimen B1 – Step 16 –linings spalling – location 9 to 11

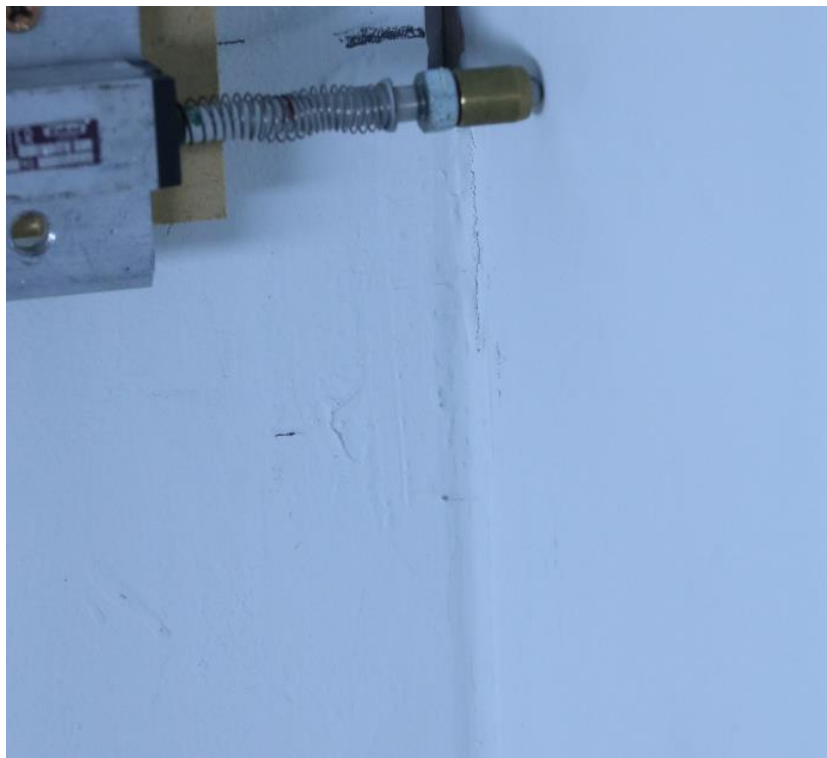
Figure C.33 Specimen B2 – Prior to test start – DS0: hairline paint cracking sealant at seismic gap–
location 11

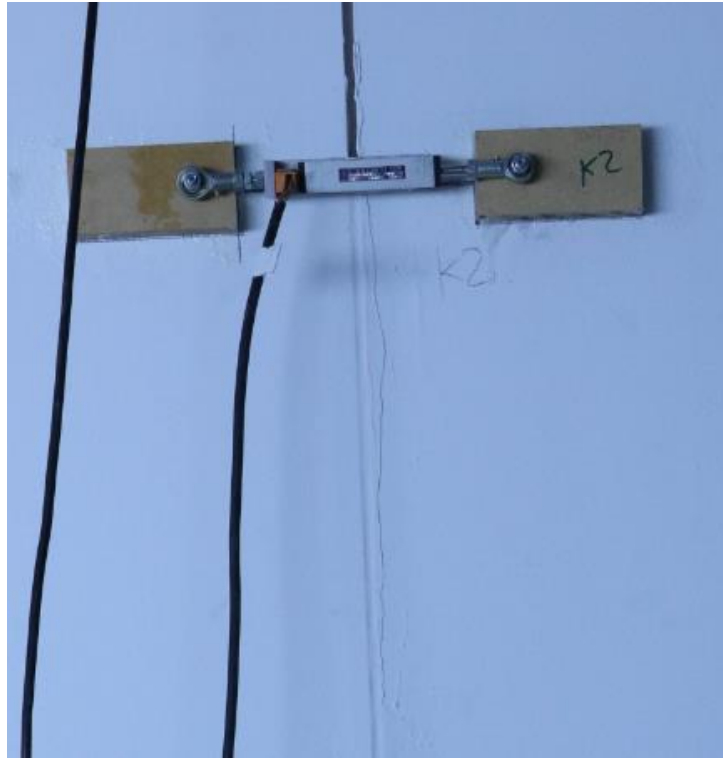
Figure C.34 Specimen B2 –Prior to test start – Poor finishing of gap filling material at intermediate joint - location 13

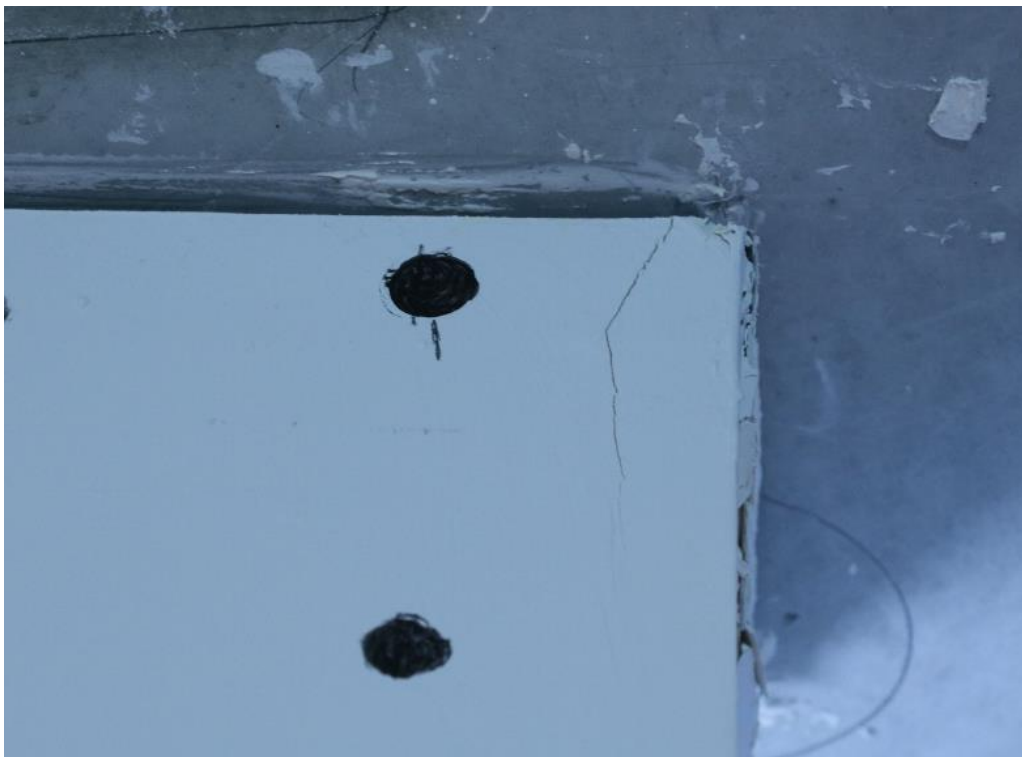
Figure C.39 Specimen B2 – Step 11 – DS1b: Plaster cracking along L-trim - location 1

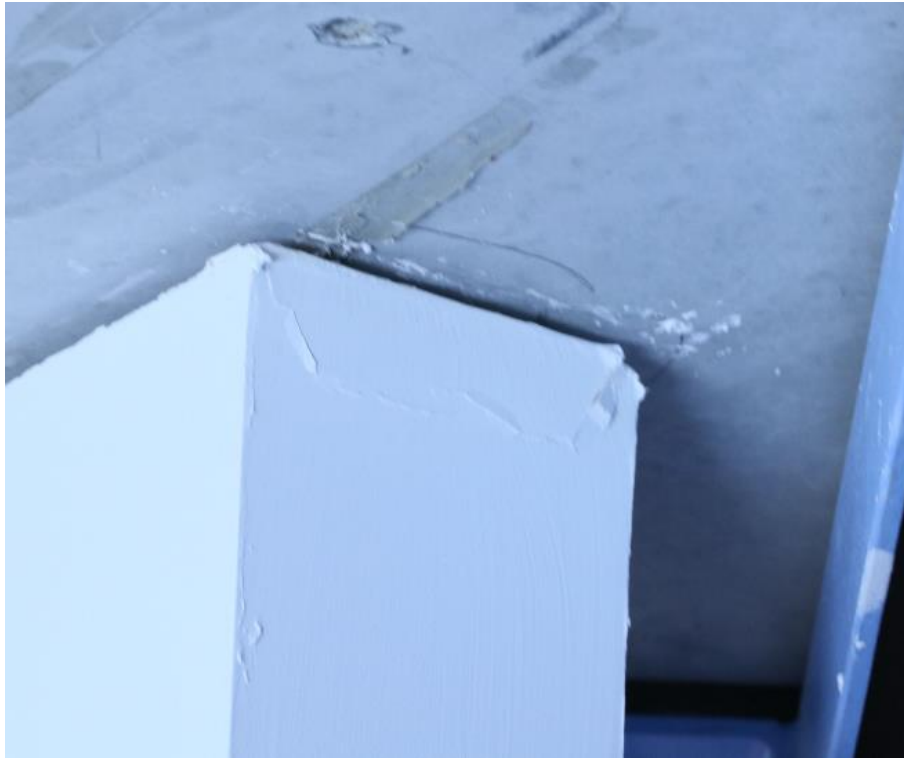
Figure C.42 Specimen B2 – Step 12 – DS1b: Plaster cracking along L-trim at wall end- location 9

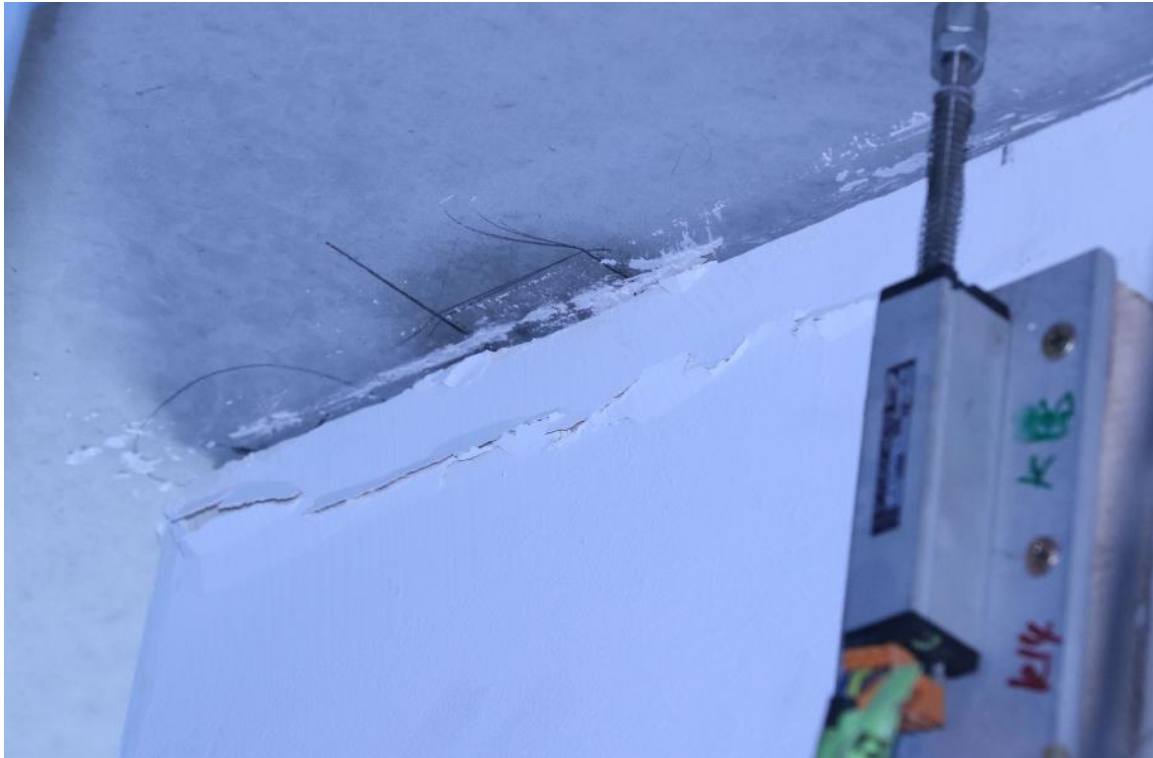
Figure C.44 Specimen B2 – Step 13 – DS1b: Cracking of plaster along L-trim – location 8

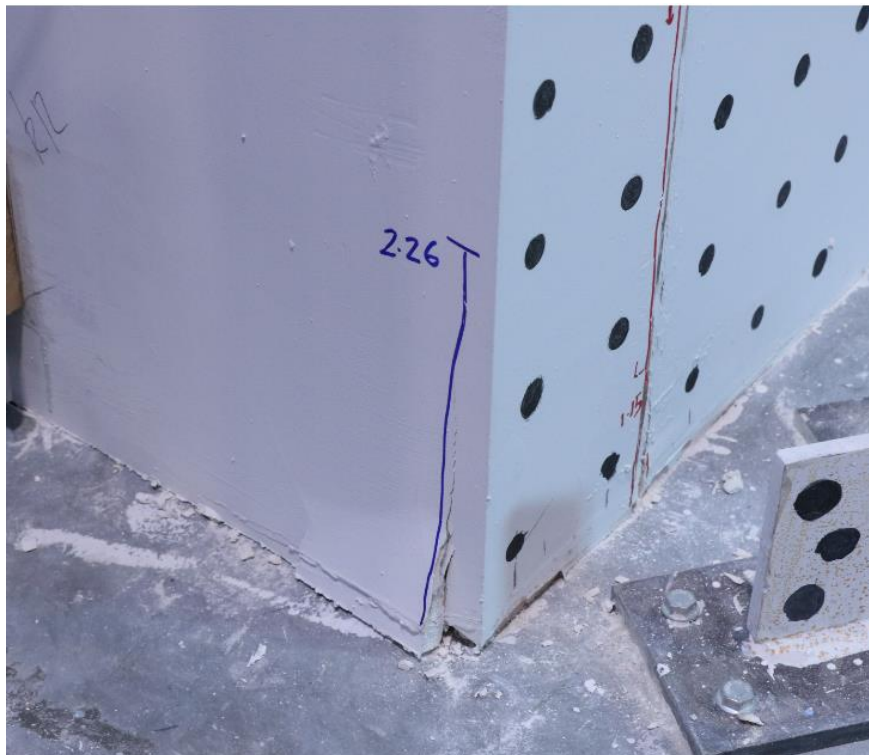
Figure C.47 Specimen B2 – Step 14 – DS2a: Wallboard damage – location 7

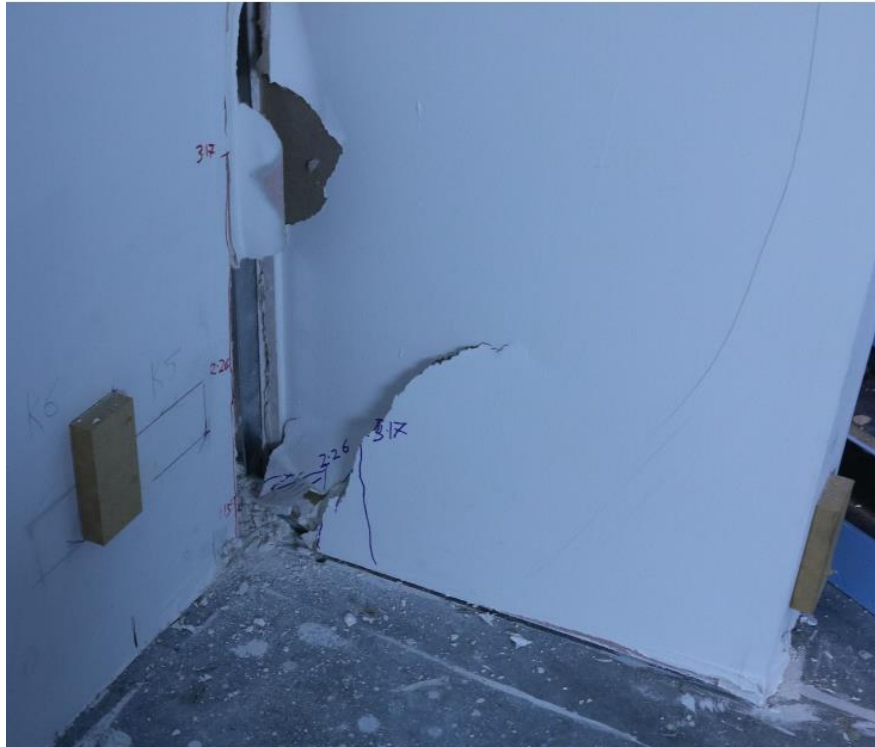
Figure C.53 Specimen B2 – Step 16 – development of damage at L-junction – location 10/11
